SPECIAL NOTICE REGARDING 1.8 5v INSTALLATION

**Service
information**
SI 0003-2003

Installation errors: misalignment of valve spring

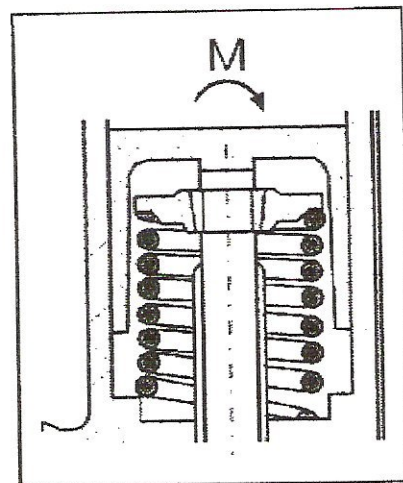
The supporting area for the valve spring at the cylinder head shows impressions of irregular depth. The valve spring is supported on one side of the higher cast edge. (See fig. 1 / spot 2 and fig. 2)

The transversal breakage of the valve in the groove area and the damage of valve guide are caused by misalignment of the valve spring.

Due to the installation position (see fig. 2), the valve spring generates a torque on the valve stem via the upper spring seat. The torque exerts a lateral force onto the end of the valve stem, thus causing a bending stress which leads to a valve stem rupture in the groove area of the valve.

Fig.2: Valve spring tilted at the higher cast edge

When the valve spring is installed, it must sit flat on the bearing surface in the cylinder head. A tilted installation of the valve spring leads to a breakage at the valve stem end and strong wear on the valve guide, resulting in costly engine damage.

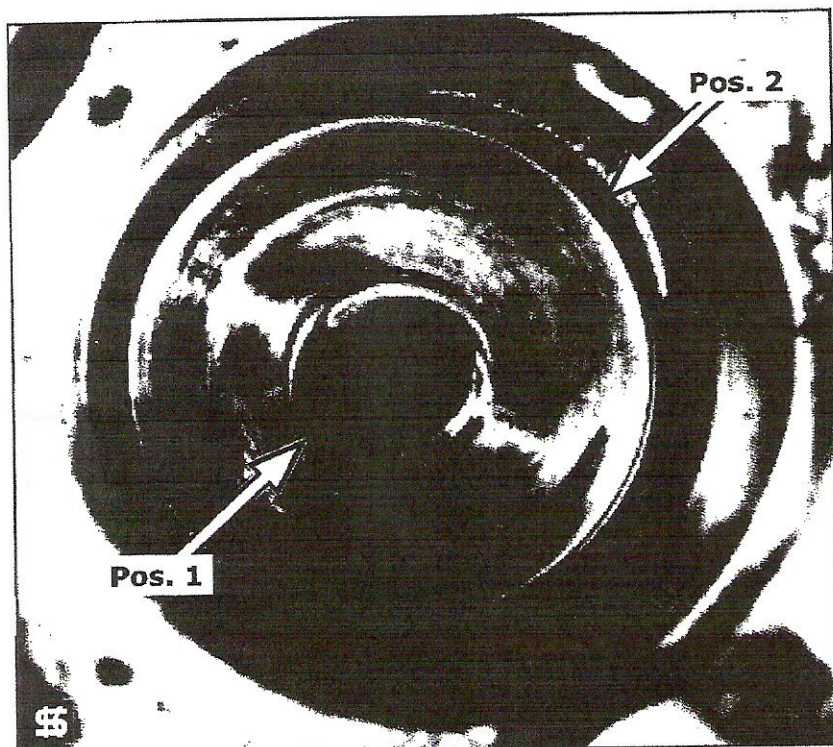
In fig.1 / spot 1, eccentric wear as well as material breakage at the valve guide end are clearly visible.

Fig.1: Valve guide damage, Eccentric wear on the valve guide caused by bending stress of the valve stem.
