# Technical Service Bulletin

## 37 TCM software update for downshift concerns

37 12 67 2028053/2 October 3, 2012. Supersedes Technical Service Bulletin Group 37 number 11 – 31 dated December 1, 2011 for reasons listed below.

Model(s)	Year	VIN Range	Vehicle-Specific Equipment
A4	2004 – 2009	All	All with 09L Transmission
A4 Avant			
A4 Cabriolet			
S4

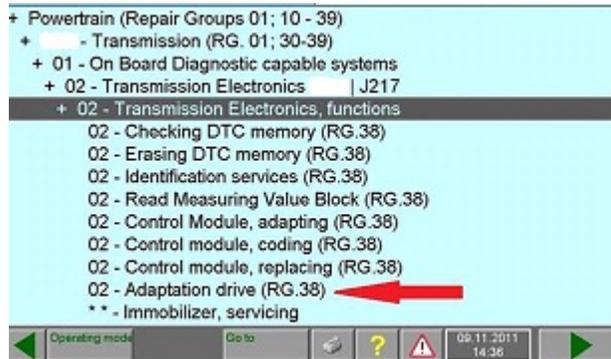
Figure 1. 02 – Adaptation drive (RG.38).

1. For early vehicles (approximately 2006 or older) there is no adaptive test drive procedure so an extended test drive is necessary driving through a variety of driving conditions including highway, stop and go, and coasting.
2. For later vehicles this test plan can be found in *GFF or Guided Functions >> Powertrain >>09L Transmission>> 01 On Board Diagnostic capable system >> 02 Transmission electronics, functions >>02-Adaptation Drive.*

3. Follow the test plan instructions completely and recheck for the concern.

**Tip:** If there is not an option to choose the Adaptation Drive shown above, then the only way to adapt the transmission is the extended test drive as described above.
